HOUSATONIC RIVER BASIN
WOLCOTT, CONNECTICUT

WOODTICK RESERVOIR DAM CT. 00294

PHASE I INSPECTION REPORT NATIONAL DAM INSPECTION PROGRAM

DECEMBER 1978

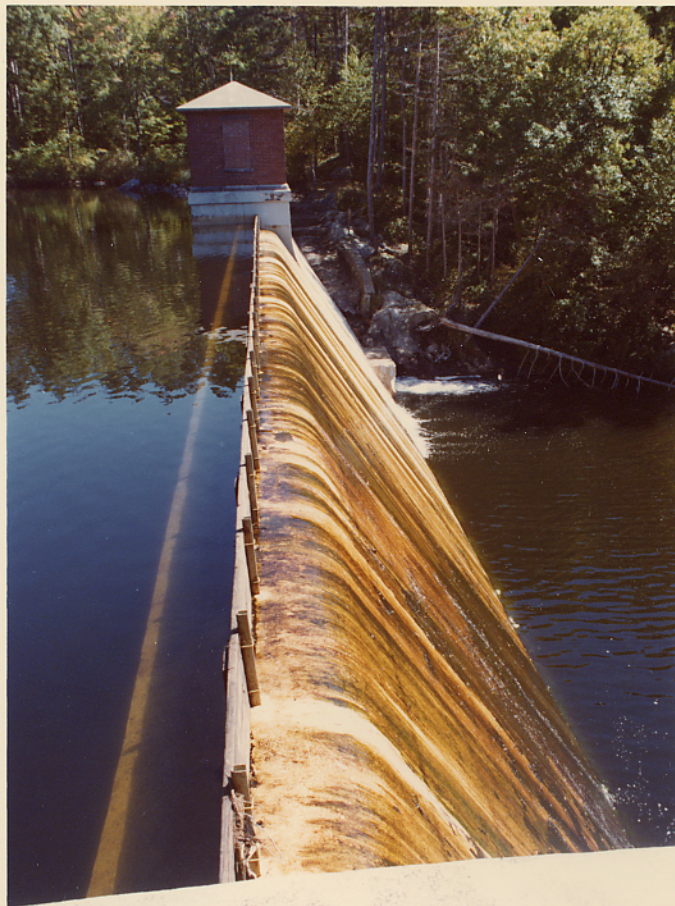
1. Several cracks and spalling spots of concrete on surfaces of the spillway, non-overflow sections, outlet and the west wall of the gate house (Appendix C, Photos 2, 7 and 8).
2. Seepage through the concrete of the west abutment with a discharge of approximately 1 gallon per minute (Appendix C, Photo 5).
3. Seepage at a downstream portion of the east toe of the dam and the juncture of the dam's concrete and rock with discharges approximately 1 to 2 gallons per minute (Appendix C, Photos 6 and 7).

PHOTO 2
CREST OF SPILLWAY LOOKING EAST

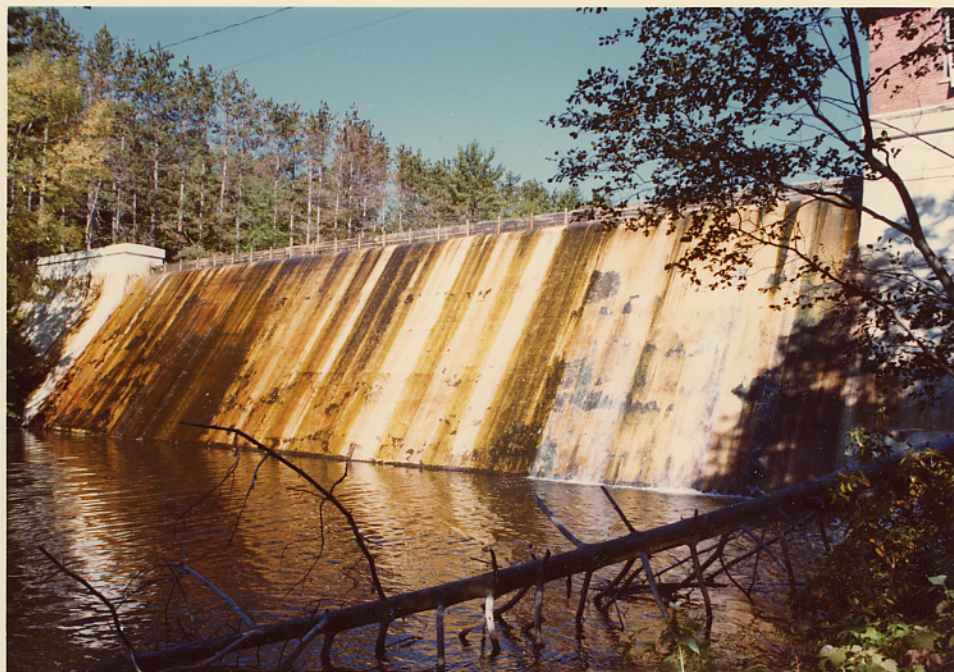
c. Visual Observations - The spillway (Appendix C, Photo 1) at the time of the inspection was in fair condition with some evidence of water seeping through its construction joints.

PHOTO 1
DOWNSTREAM FACE OF SPILLWAY

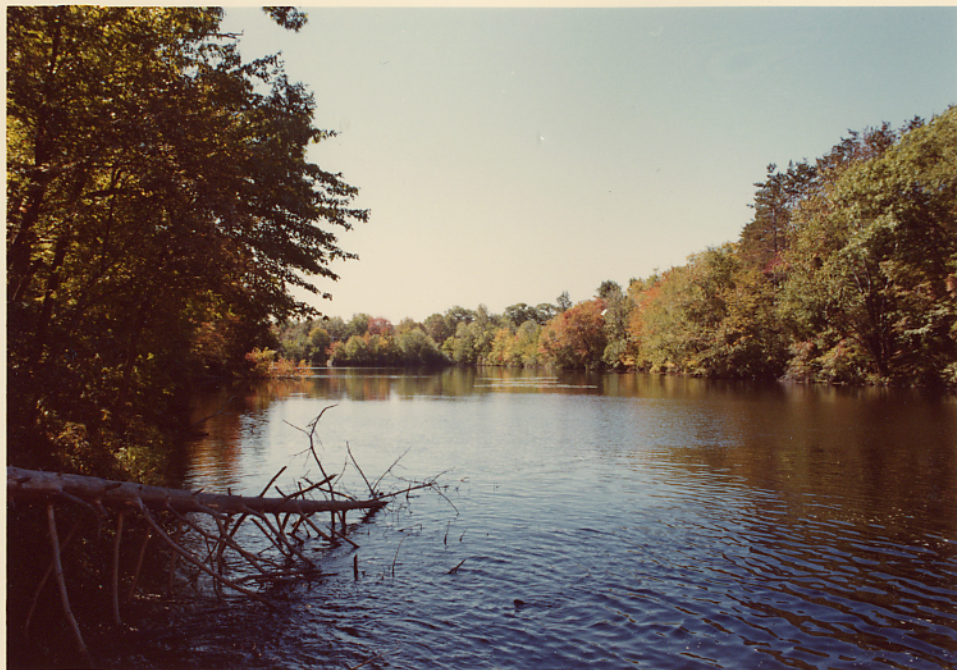
e. Downstream Channel - The downstream channel of the spillway (Appendix C, Photo 4) is overgrown with trees with a series of smaller dams just downstream. Along the toe of the east side of the dam, there is an area on the bank which stays moist from the seepage flow through or under the body of the dam (Appendix C, Photo 6). There is also evidence of a seepage flow on the east bank in the area of the rock and concrete interface (Appendix C, Photo 7).

PHOTO 4
AT TOE OF DAM LOOKING DOWNSTREAM

- a. Alternatives - Not applicable.
- b. O & M Maintenance and Procedures -
 1. Brush and trees on the downstream area at the distance of 10 feet from the toe of the dam should be removed to facilitate the visual observation of existing and potential seepage.
 2. Weakened, damaged and fissured concrete of the dam should be repaired.
 3. The gate house and equipment should be inspected and access to the gate house should be made readily available.

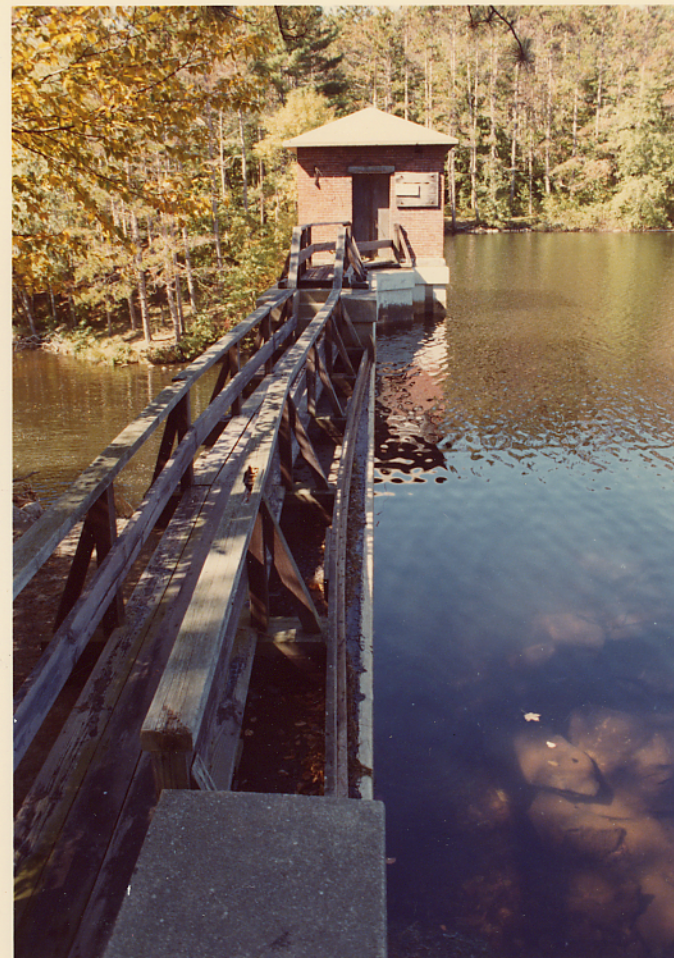
c. Appurtenant Structures - The appurtenant structures are the wooden service bridge over the emergency spillway and the attached gate house (Appendix C, Photo 3). An attempt was made to inspect the inside of the gate house, but the door was locked. The exterior of the gate house was in good condition. Maintenance personnel indicated that valves were operational, but there were some problems with vandalism in the area. The wooden bridge to the gate house that crosses over the emergency spillway shows some signs of damage such as a permanent warp from prior floods and some rotting timbers (Appendix C, Photo 3).

PHOTO 3
CREST OF EMERGENCY SPILLWAY LOOKING WEST

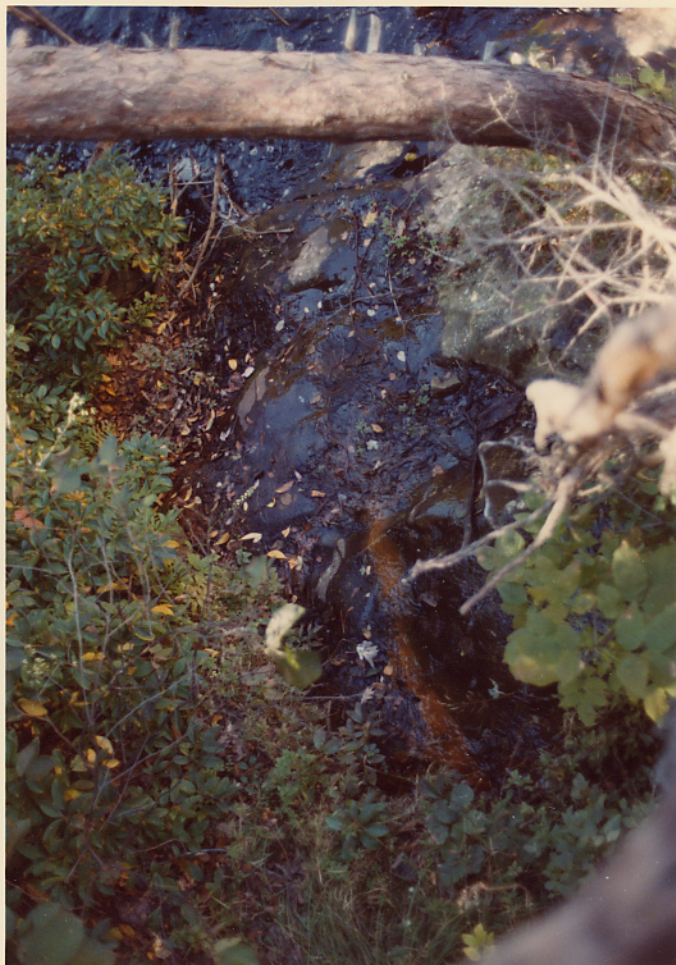
PHOTO 6
SEEPAGE AT TOE OF DAM

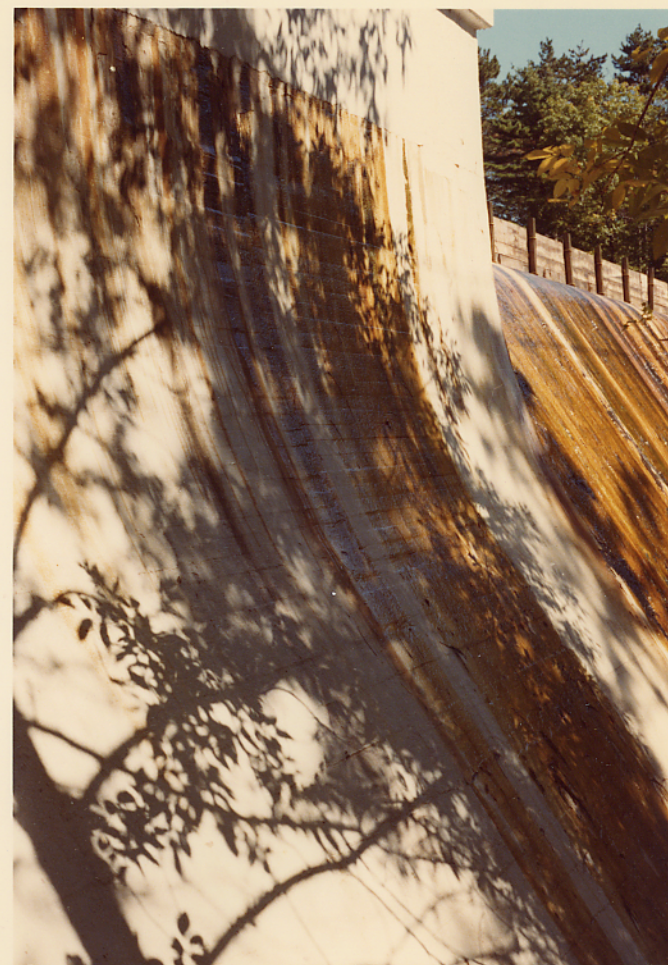
seepage (Appendix C, Photo 5) in several areas. The following are observations noted during the inspection:

PHOTO 5
SEEPAGE THROUGH BODY OF DAM

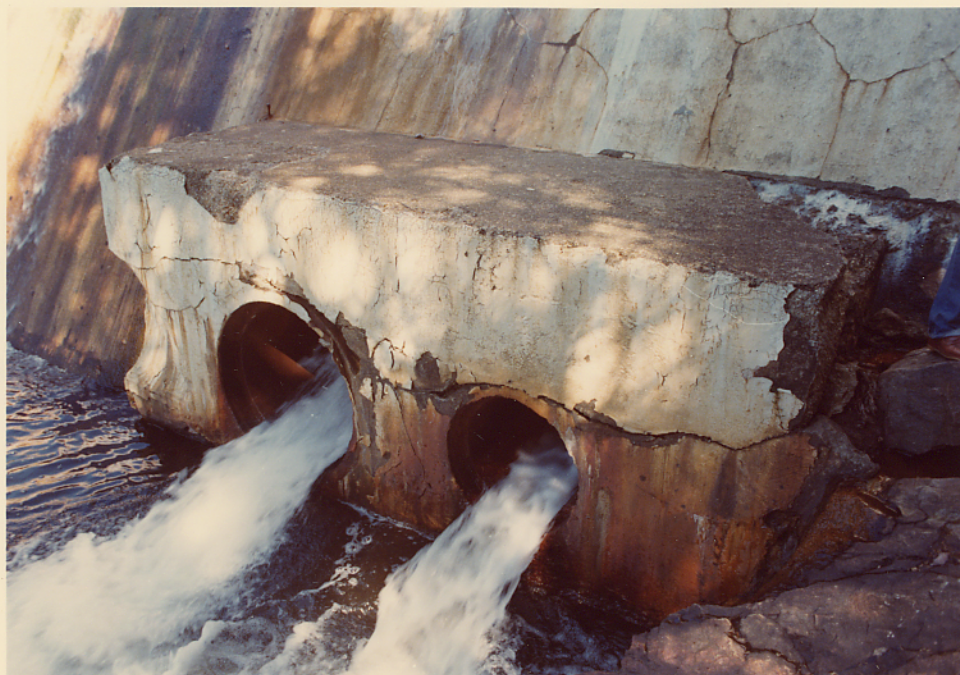
The 30 inch and 20 inch blowoff are in good condition.

PHOTO 8
VIEW OF BLOWOFF AT THE TOE OF DAM

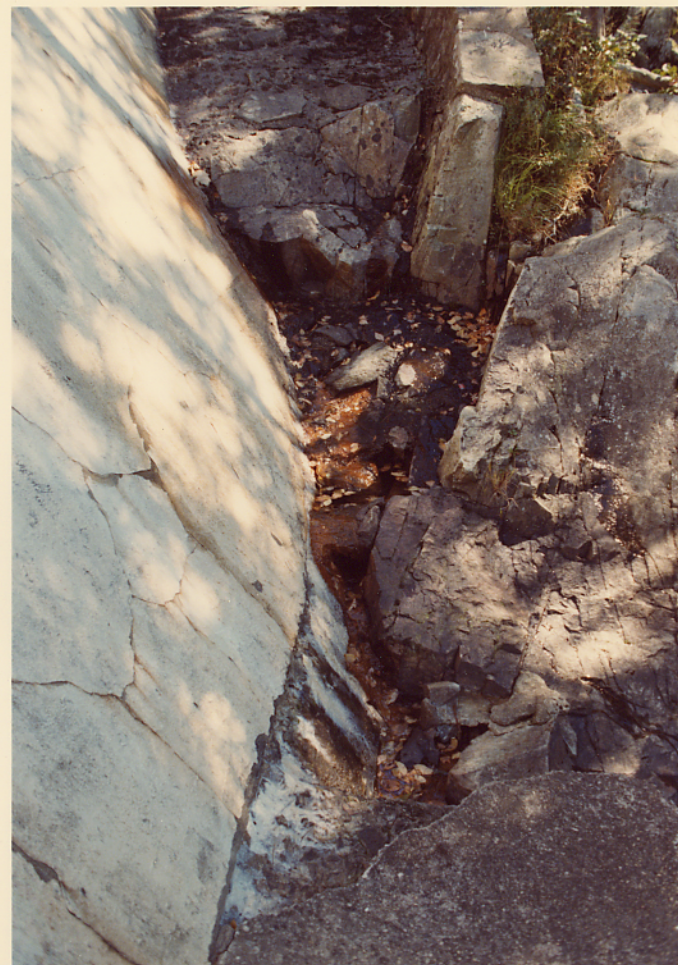
PHOTO 7
SEEPAGE OF DAM AT INTERFACE OF ROCK
